VIBRATION SURVEY OF BLADES IN 10-STAGE

AXIAL-FLOW COMPRESSOR

II - DYNAMIC INVESTIGATION

By André J. Meyer, Jr.
and Howard F. Calvert

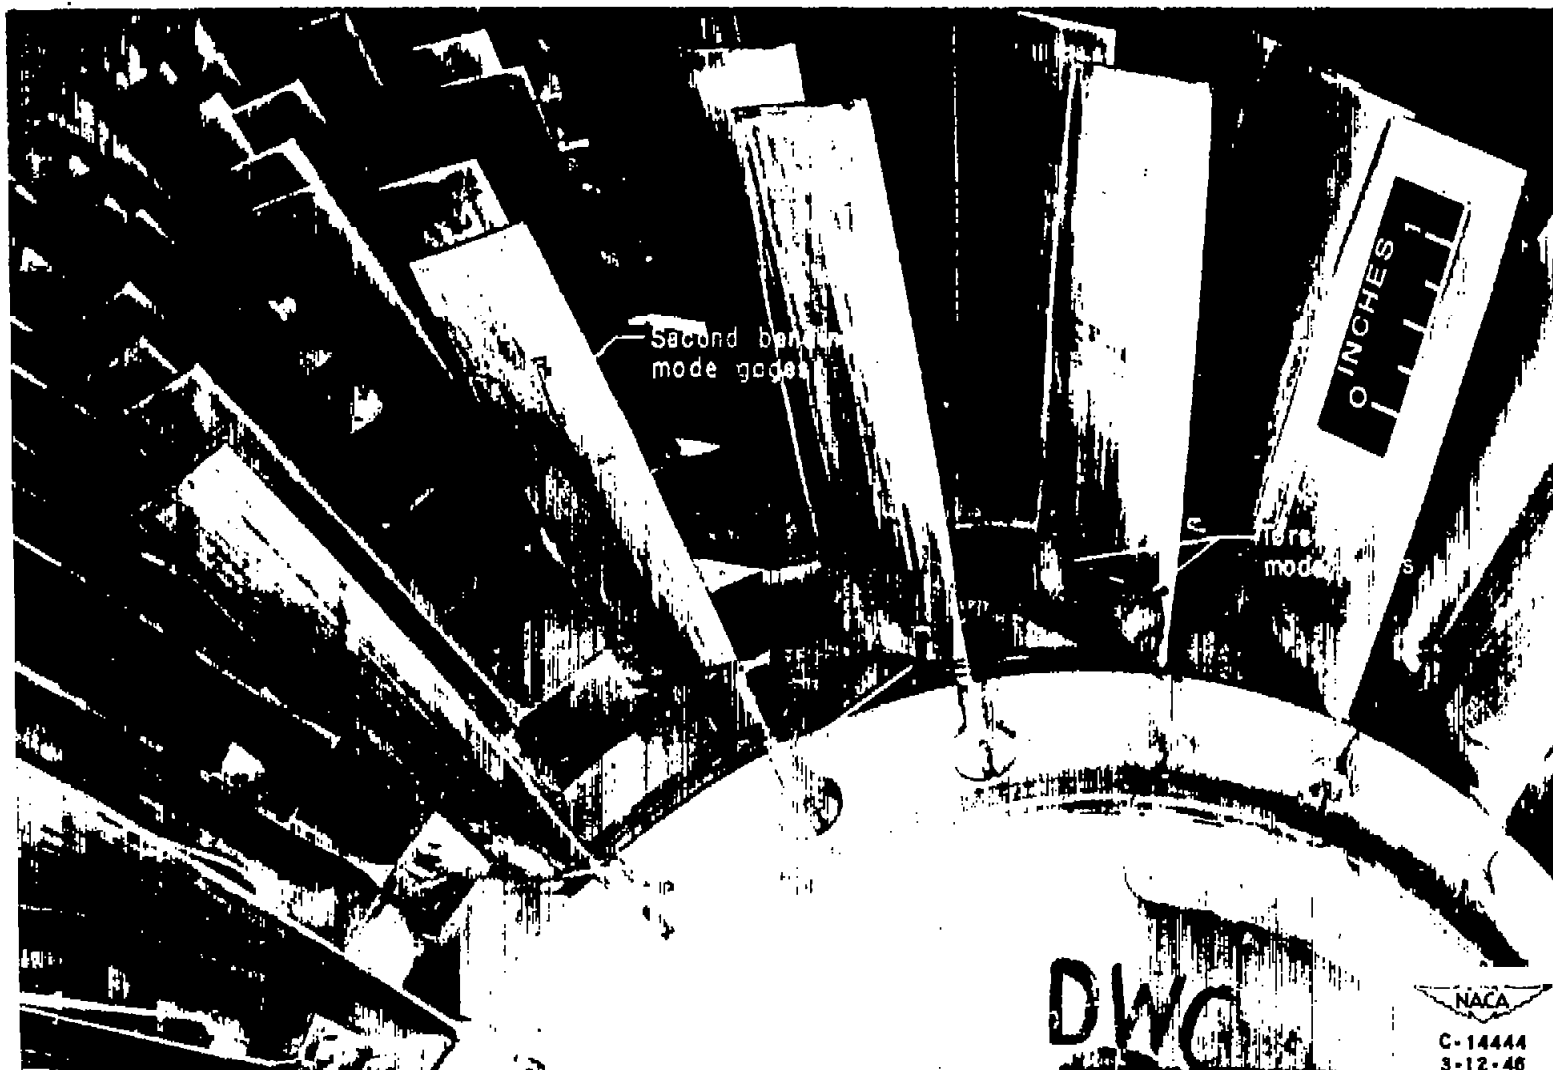
Figure 1. - Strain gages mounted on blades of first stage of 10-stage compressor.

For checking purposes, 36 active strain-w bridges were mounted on blades of the various stages with at least two bridges per stage. The gages were mounted on the blades with Bakelite cement with the resistance-wire filaments parallel to the direction of maximum compressive and tensile stresses for the mode of vibration in question (fig. 1). Some of the gages were used to detect bending vibrations and others to detect torsional vibrations. The construction of the gages is similar to that outlined in reference 2.
